## NTSB News Release

### NTSB Calls for National Safety Standards for Limousines

10/2/2019

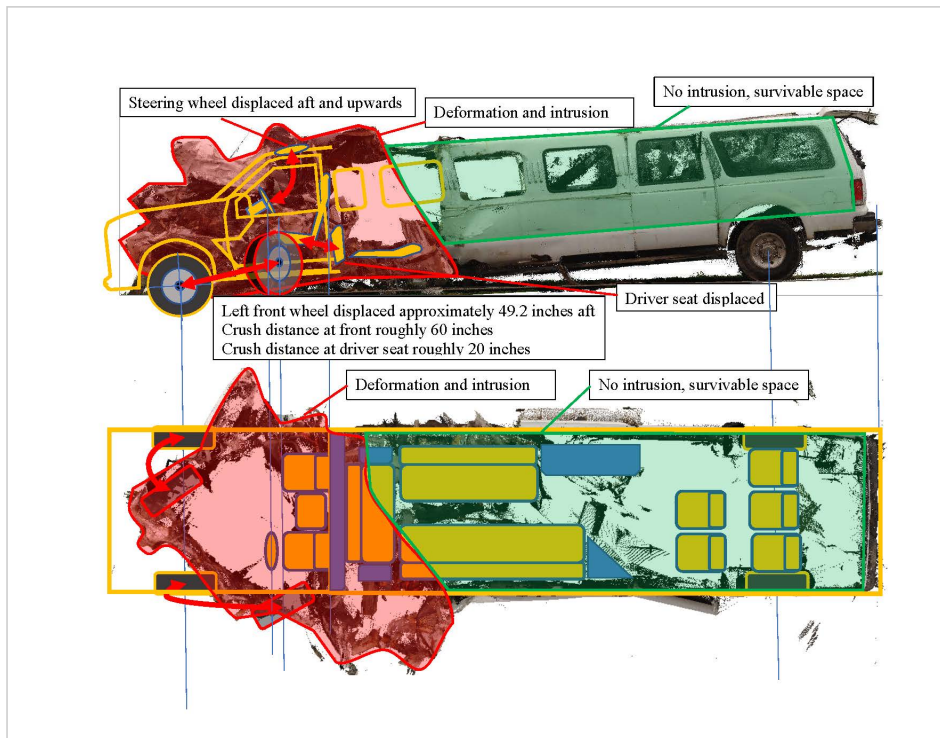
(Side- and overhead-view post-crash 3D image of the Schoharie limousine with an overlaid reconstruction of the vehicle's pre-crash structure. NTSB graphic)

The 2001 Ford Excursion involved in the Schoharie crash was significantly modified. It was stretched 144 inches and the interior in the stretched region was reconfigured with perimeter-style bench seating. The three benches were equipped with passenger lap belts.

In addition to the bench seats, five of the six original rear seats were retained, along with their factory-equipped lap/shoulder belts. The NTSB post-crash inspection indicated 21 belted seating positions, although seating positions could range from 18 to 22, depending on how a position is defined.

After the collision, the NTSB found the side- and rear-facing bench seats failed in the direction of the crash forces and that the strength of these seats and their anchorages were inadequate during the crash. In comparison, the original Ford passenger seats in the rear of the vehicle remained attached to the floor and intact.

The NTSB's [Safety Recommendation Report](#) recommended that the [National Highway Traffic Safety Administration](#) require lap/shoulder belts for each passenger seating position on all new vehicles modified to be used as limousines. It also requires seating systems in these vehicles to meet minimum performance standards to ensure their integrity during a crash.
